Appendix A

Hydraulic Structure Data Collection

Central Coast Highway 1 Climate Resiliency Study
Figure A-1
 Hydraulic Structure Locations
 Surveyed by ESA on 11/13/2018

Figure A-2

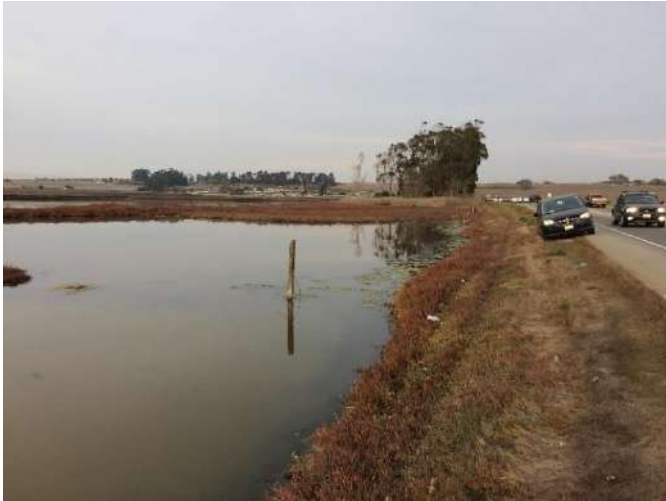
Reach 1 culvert located underneath vegetation)

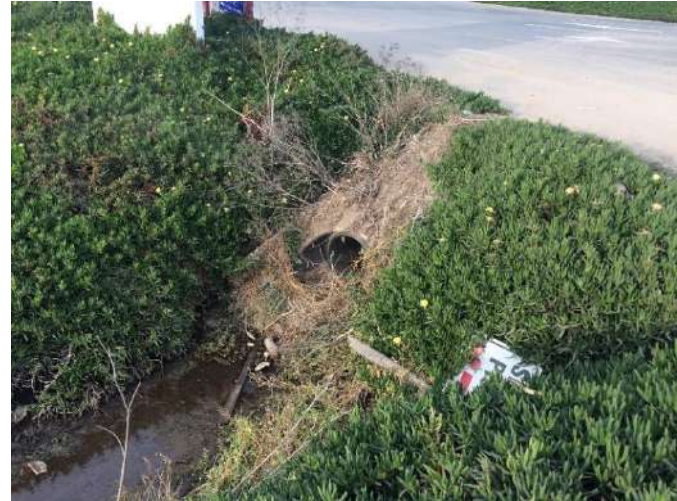
In Reach 2, the culverts connecting flow from Lower to Upper Bennett Slough were crushed; little to no tidal influence reaches Upper Bennett Slough and Struve Pond, which matched previous and existing qualitative observations of those hydrologic systems. Figure A-2 shows the condition of culverts surveyed. All survey data were taken with respect to horizontal datum California State Plane (CASP) Zone 4 and North American Vertical Datum (NAVD88) and in English units.

Reach 2 culvert by Bennett Slough

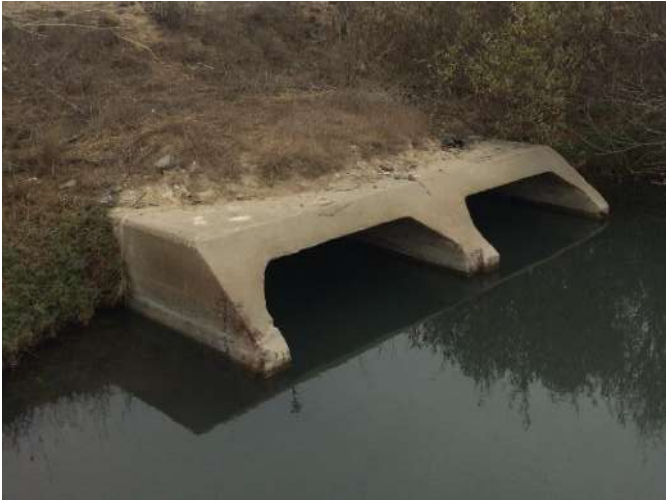
Reach 3 dual concrete culverts

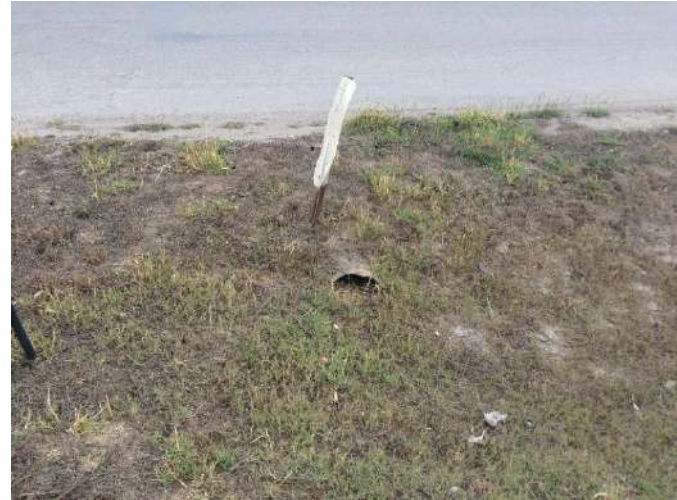
Reach 4 culvert (note structure is filled in)
